Case Report

Retrieval of a Ruptured PTMC Balloon

Department of Cardiology, AIIMS, India

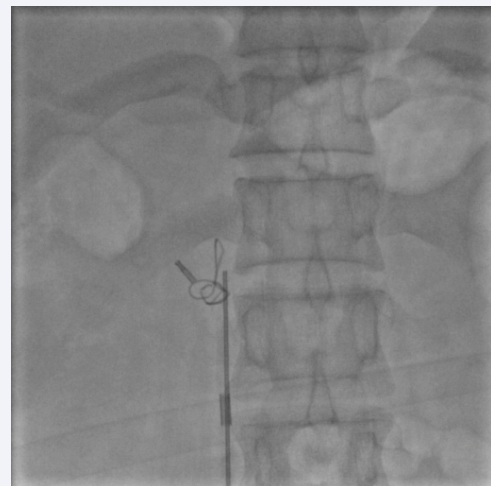
Figure 1 Fluoroscopic image showing PTMC balloon ruptured by distal tip of coiled guide wire and inner metal tube.

PTMC procedure was done through right femoral vein approach using Sym PTMC balloon (CE mark). After successful completion of a PTMC procedure, when the PTMC balloon was being withdrawn; firstly the coiled guide wire perforated the balloon (both inner and outer layers) and then the inner tube perforated the balloon (both inner and outer layers) in an attempt to slenderize the balloon (Figure 1). The distal portion of coiled

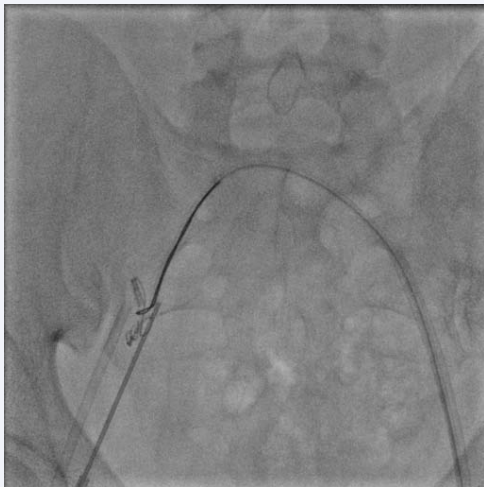
Figure 2 Snare from the left femoral vein catching the tip of balloon in an attempt to straighten the balloon while it is being taken down through the right femoral vein.

sterilized balloon getting ruptured by the round guide wire and inner metal tube after successful completion of the procedure. Inability to take out this balloon through the right groin because of folding of distal tip of balloon and associated risk of tearing of femoral vein lead to the use of snare from the contra lateral femoral vein to hold the tip of the balloon with snare to provide a tug to straighten the distal tip of the balloon, so that it can be taken out of the right femoral vein. This is the novel technique first time described in the literature with successful result.

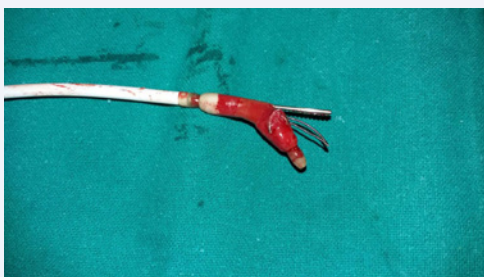
Figure 3a Perforated PTMC balloon out of the body.

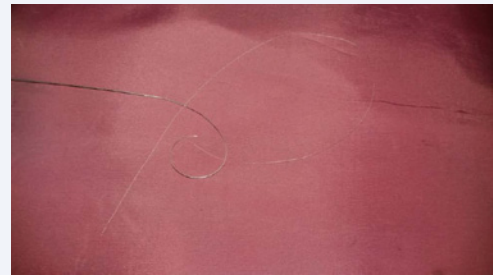
Figure 3b Broken coiled guide wire.

guide wire was stucked in the PTMC balloon after perforating it and it cannot be moved either back or forth because it was now connected to the rest of the coiled guide wire with only a few springs elongated inside the inner metal tube of the PTMC balloon with distal end of the round wire moving freely. When the whole assembly of PTMC balloon was tried to bring down through the right femoral vein, the distal most portion of the balloon was not coming out because it folded on itself. Then the whole assembly was again taken up to the inferior vena cava below the right atrium. Then a snare was inserted from the left femoral vein in the view of catching the tip of the balloon to make it straight with the tug of the snare from the left side (Figure 2). Then the straighten balloon along with the snare were taken out of the right femoral vein (Figure 3a, Online video 1). After detaching the snare from the balloon tip, snare was taken out of the left femoral vein (Online video 2). The broken elongated spring wire is shown in the (Figure 3b).

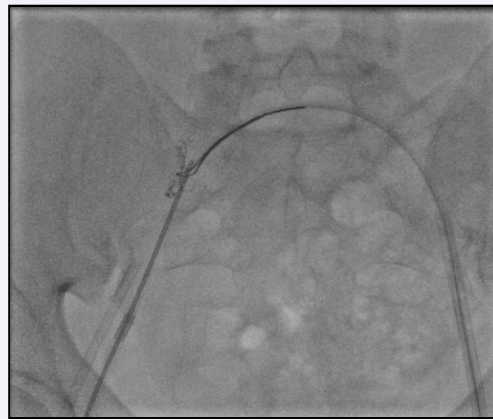
Video 1 Snared PTMC balloon being taken out through right femoral vein.

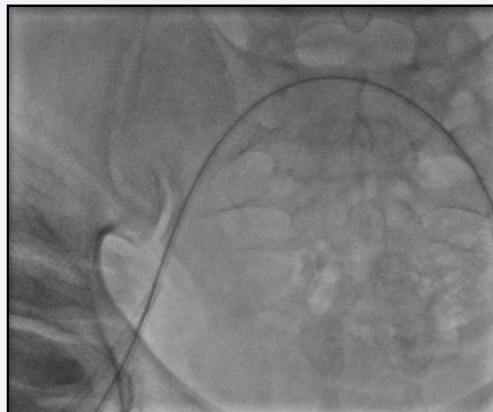
Video 2 Snare being taken out through left femoral vein.
