Case Report

Adverse Reactions to Metal Debris after Fully-Modular Primary Total Hip Arthroplasty: A Report of Two Cases

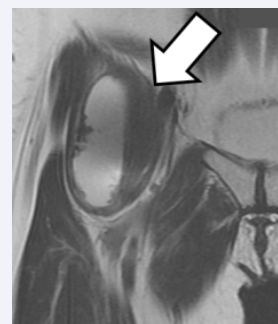
Figure 3 T2-weighted coronal MR image in Case 1 (Arrow: pseudotumor).

(APLIO XG SSA-790A PLT-805AT, Toshiba Medical Systems Corp., Tokyo, Japan) showed a mixed fluid and solid mass (Figure 2). Magnetic resonance imaging (MRI) (Signa HDxt 1.5T Optima Edition GE Healthcare, Tokyo, Japan) demonstrated a large pseudotumor around the anterior hip joint (Figure 3). Diagnosed as ARMD, she underwent revision surgery. A large amount of abnormal fluid, ranging from milky white to yellow in color (Figure 4), was encountered on incising the tensor iliotibial band through a posterolateral approach. Metal concentrations of the joint fluid were Co 640 ng/ml and Cr 100 ng/ml. Intraoperative cultures were negative. Hypertrophy of the synovial tissue and a huge pseudocapsule were noted and completely resected. The femoral head-neck junction demonstrated obvious corrosion (Figure 4). The modular neck and femoral components were well-fixed. The 40-mm metal head, neck, and stem were replaced with a 32-mm delta ceramic head BIOLOX® (CeramTec AG, Plochingen, Germany) and Profemur R® stem (Ti, 6Al, 4V). Histological examination showed peri vascular lymphocyte infiltration, necrotic tissue, and giant cells (Figure 5).

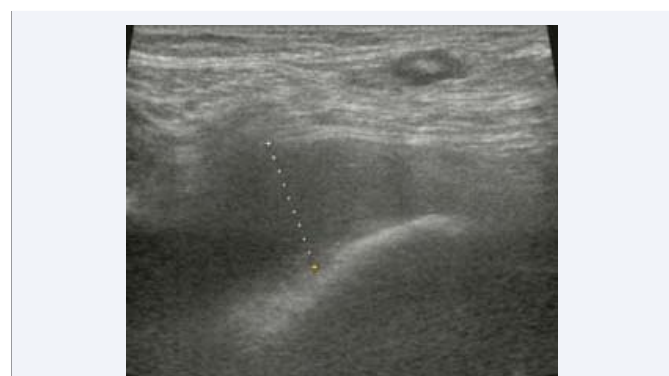
Figure 7 Ultrasound scan around the hip in Case 2 demonstrating a low echoic mass.

used to implant a 52-mm Trident® acetabular cup with a 3.8-mm thick X3® UHMWXP insert, a Profemur Z® femoral stem with a 4.5° retroverted and 6° varus neck, and a 40-mm Conserve Plus® medium metal head (Figure 6). Two months after surgery, she felt discomfort around the right hip joint, but no pain. Although she had a normal range of hip motion, she felt difficulty when she lifted her right leg, and needed a cane to walk. The symptoms continued up to revision surgery. Inflammatory serology was normal. Plain radiographs did not show any impending implant failure, but calcar osteolysis was visible 3 years after implantation (Figure 6). An ultrasound scan showed fluid collection around the hip joint. MRI demonstrated a large pseudotumor around the hip joint (Figure 7). Diagnosed as ARMD, revision surgery was performed.

To identify these reactions, a specialized metal artifact reduction sequence (MARS) MRI has been recommended [26]. However, our institution was not equipped with this expensive system, and diagnostic ultrasonography was chosen as a screening tool instead [4,27,28]. As shown in Figure (2) and Figure (7), the latter tool was economical and cost-effective compared to MRI [29]. For arthrocentesis, it was easy to demonstrate the area of fluid collection. Finally, ceramic heads were used for revision surgery. This procedure was supported by several reports [19,26,30]. Goyal et al., reported good results of THA with adverse local tissue reactions by a ball (Co-Cr alloy) and liner exchange without stem (Co-Cr alloy) revision [31]. However, we chose ceramic heads for the newly implanted Profemur-R® stems and modular necks.

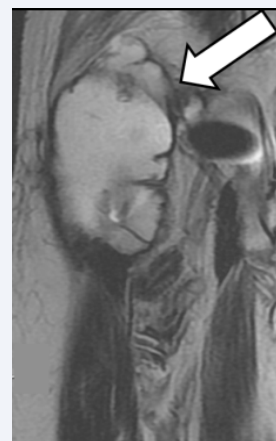
Figure 8 T2-weighted coronal MR image in Case 2 shows a pseudo tumor (arrow).
