Case Report

Conservative Retrieval of Fractured Abutment Screw – A Case Report

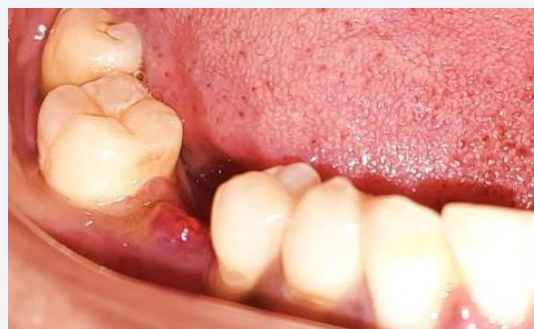
Figure 1 Implant head covered by soft tissue.

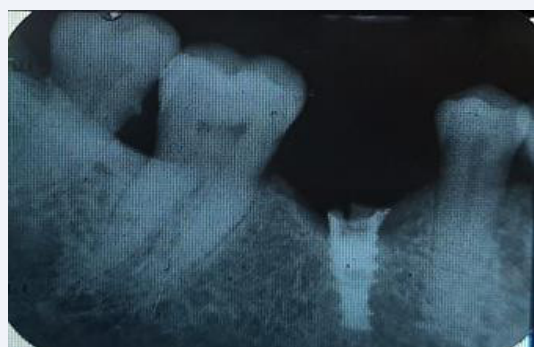
A 56 year old female patient presented to the Department of Periodontics, Krishnadevaraya Dental College, Bengaluru with a chief complaint of dislodged healing abutment with respect to an implant placed in the mandibular right first molar since 1 month. The patient stated that implant was placed 1 year back and was restored using cement retained metal ceramic crown. Intraoral examination revealed that the implant head was enclosed by the soft tissue. There was presence of suppuration (Figure 1). Further radiographic assessment confirmed the presence of the fractured abutment screw threaded into the implant with no indication of any damage to implant body and evidence of marginal bone loss (Figure 2).

Figure 2 Radiograph showing fractured fragment within the implant body.

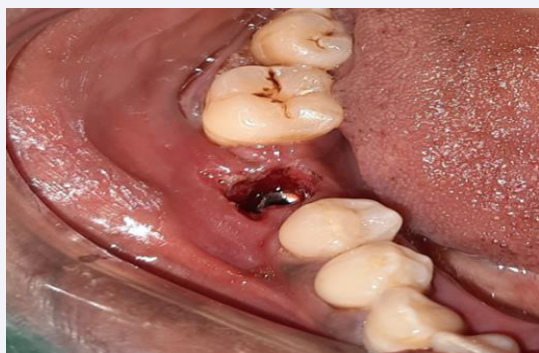
Figure 3 Implant exposed using diode laser.

1. After anesthetizing the area, horizontal incision was given on most fluctuant area and pus was drained by using curette.
2. Implant exposure was done using the diode laser (810 nm wavelength), which was inserted at the center of the site and worked in a spiral pattern outward until the entire cover screw was exposed. Then curette was used to release the tissue over the cover screw (Figure 3).

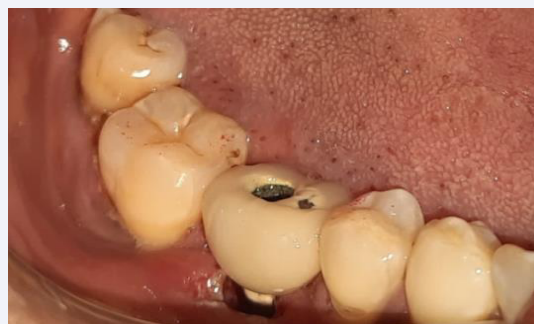
Figure 5 New abutment tightened to the implant body with a screw and cemented with prosthesis.

8. Using the air/water spray the internal surface of the implant was again cleaned.
9. The new abutment was then tried for the fit and preservation which helps to confirm the absence of damage of internal retentive structure of the implant.
10. New abutment was tightened to the implant body with a screw, existing prosthesis was cemented (Figure 5) and radiograph was taken (Figure 6).
11. The patient was instructed on the use of 0.12% chlorhexidine mouthwash, systemic antibiotics (amoxicillin 500 mg thrice daily for 3 days and metronidazole 400 mg twice daily for 3 days) and was seen intermittently for professional oral hygiene maintenance during the follow-up period.

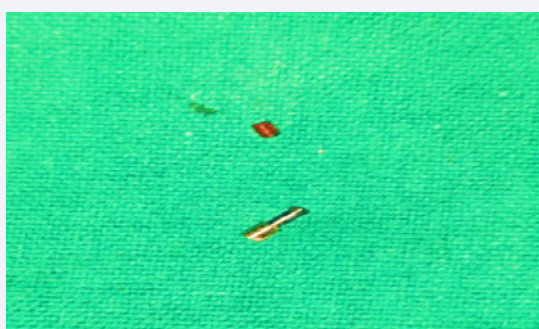
Figure 4 Fractured abutment screw.

4. The piezoelectric ultrasonic scaler tip (EMS-Tip P) was placed on upper surface of the fractured abutment screw.
5. The scaler tip was held firm on the upper surface of the fractured fragment and the oscillations were started with minimal power and copious irrigation.

6. When the vibrating scaler tip contacted the surface of the screw, a moderate reverse torque was applied alternatingly and fractured abutment fragment spun out of the implant body (Figure 4).

7. As the fractured abutment screw fragment started loosening, the tip contacting the screw fragment was gradually decreased. The loosened abutment screw was then removed with a tweezer.

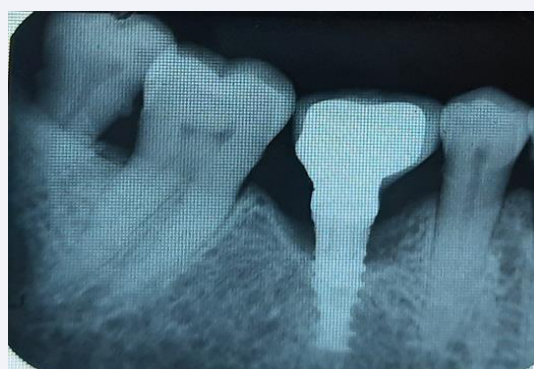
Figure 6 Radiograph after prosthesis placement.

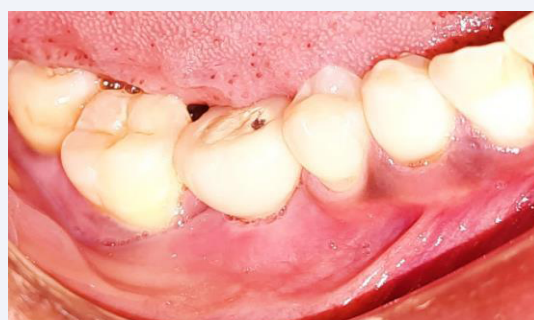
Figure 7 1 month follow up.
