Case Report

Extraction of a 30-Year-Old Pacemaker Lead Implanted Through the Right Femoral Vein Using a Combination of Sheaths and a Femoral Work Station: A Case Report

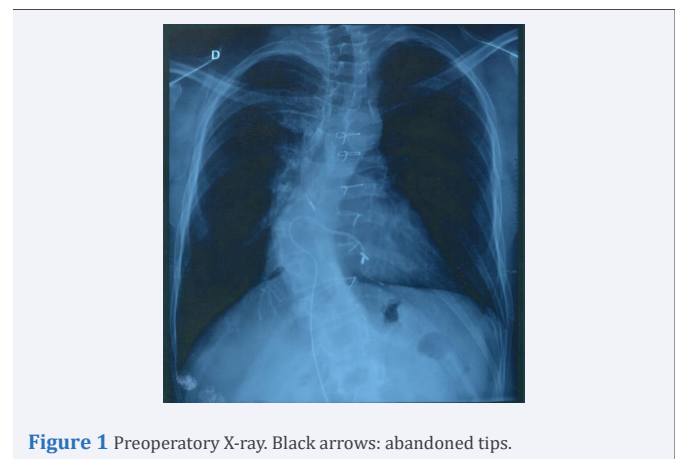
Figure 1 Preoperative X-ray. Black arrows: abandoned tips.

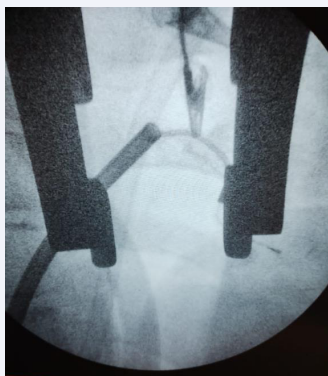
Figure 2 Femoral work station. The sheath entering the right ventricle.

The lead was implanted through the right femoral vein (Unknown model), which posed a challenge for lead extraction. We used a combination of sheaths and a femoral work station to safely extract the lead. A locking style (Spectranetics/Philips) was

used to lock the lead in place. We then used a series of sheaths, including metal sheaths (medium) (Cook Medical) to enter into de Femoral and Iliac vein, polypropylene sheaths (10 and 11.5 Fr) (Cook Medical) through the iliac vein, and a Tight Rail (11 Fr) (Spectranetics/Philips) along the inferior vena cava for along 45 cm from the entrance, and then a Byrd Femoral Work Station (Cook Medical) to remove the lead, (Figure 2). Calcium rings were found along the lead. There was scar tissue all along the lead in the femoral, iliac and the inferior vena cava (Figure 3 Computed tomography). Tools used, were for the superior

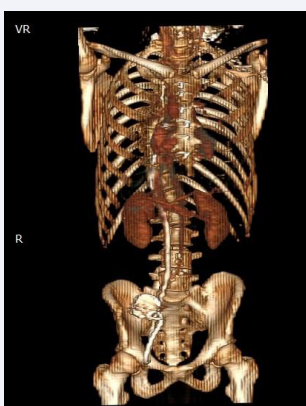
Figure 3 TAC showing scar tissue along the lead.

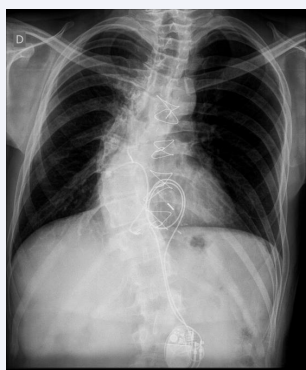
Figure 4 Post-operative X-ray Black arrows: abandoned tips.

approach, and the only sheath that reached the heart was the femoral work station. Sheaths were change due to the tortuosity of veins. The tip was left inside the heart, with a procedure clinical success [Figure 4]. During the procedure, heart rhythm was maintained with temporary epicardial lead. A dual chamber epicardial pacemaker was implanted in the same procedure, with two screws in bipolar leads, with steroids. Nine months later, uneventful post-operative.
